HISTORIC RESOURCES INVENTORY
BUILDING AND STRUCTURES
 HIST-6 NEW 5/77

3. STREET AND NUMBER (and/or location): 566 West Main Street Map: 49, Block: 273,248

IDENTIFICATION	1. BUILDING NAME (Common) (Historic)	
	David Badger House	
	2. TOWN/CITY	VILLAGE COUNTY
	Cheshire	New Haven
	3. STREET AND NUMBER (and/or location)	
	571 West Main Street Map: 49, Block: 9, 11

3. STREET AND NUMBER (and/or location): 610 West Main Street Map: 49, Block: 113

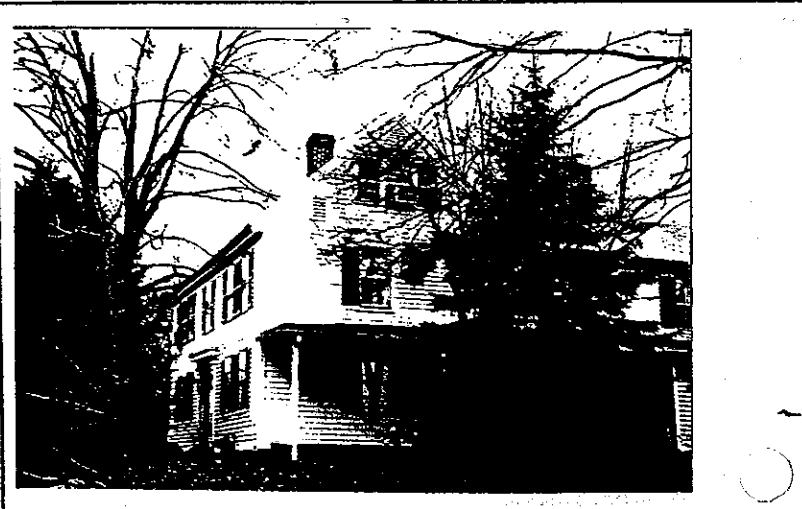
PHOTOGRAPHER: Historic Resource Consultants
DATE: 11/85
VIEW: NW
NEGATIVE ON FILE: A-1A

<input type="checkbox"/> Excellent	<input checked="" type="checkbox"/> Good	<input type="checkbox"/> Fair	<input type="checkbox"/> Deteriorated	<input type="checkbox"/> Excellent	<input checked="" type="checkbox"/> Good	<input type="checkbox"/> Fair	<input type="checkbox"/> Deteriorated
------------------------------------	--	-------------------------------	---------------------------------------	------------------------------------	--	-------------------------------	---------------------------------------

Five-bay facade with central entry. Entry treatment is from Greek Revival period (c.1845) and has paneled pilasters and molded cornice. Two-over-two sash. Victorian open side porch with turned posts.

Although later updated in the 19th century, this house is significant as an example of 18th-century domestic architecture. It embodies many of the distinctive characteristics of the type: the center-chimney gable-roofed form, the five-bay facade, and the clapboarded exterior.

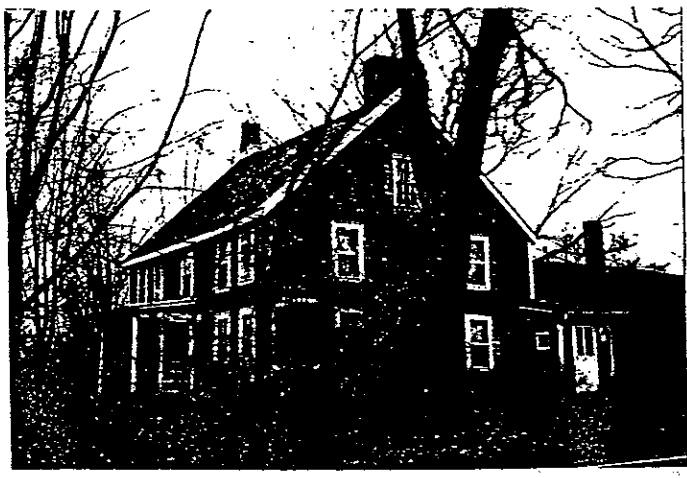
VIEW: W NEGATIVE ON FILE: A-3 A

11. NUMBER OF STORIES APPROXIMATE DIMENSIONS		
2-1/2 36 X 28'		
12. CONDITION (Structural) (Exterior)		
<input type="checkbox"/> Excellent <input checked="" type="checkbox"/> Good <input type="checkbox"/> Fair <input type="checkbox"/> Deteriorated <input type="checkbox"/> Excellent <input type="checkbox"/> Good <input checked="" type="checkbox"/> Fair <input type="checkbox"/> Deteriorated

13. INTEGRITY (Location) WHEN? (Alterations) IF YES, EXPLAIN		
<input checked="" type="checkbox"/> On original site <input type="checkbox"/> Moved <input checked="" type="checkbox"/> Yes <input type="checkbox"/> No Siding, sash

Faces east. Facade (broad side) is five bays wide with center entry. Two chimneys near ends of ridge (south chimney smaller than original). Shed-roofed entrance porch (20th century). Victorian two-over-two sash, with six-over-six windows in the gables. Beaded corner boards.

Small frame 19th century barn (remnant) in rear; vertical board siding.

This house is a good example of late 18th-century vernacular architecture. Its five-bay, gable-roofed form is traditional, though the two-chimney plan shows the transition to the more formal, central-hall lay-out favored in the years after 1800. Despite changes over time, the house's essential form is unchanged and its historic appearance is easily imagined from remaining original fabric such as the small-pane sash and molded corner boards.

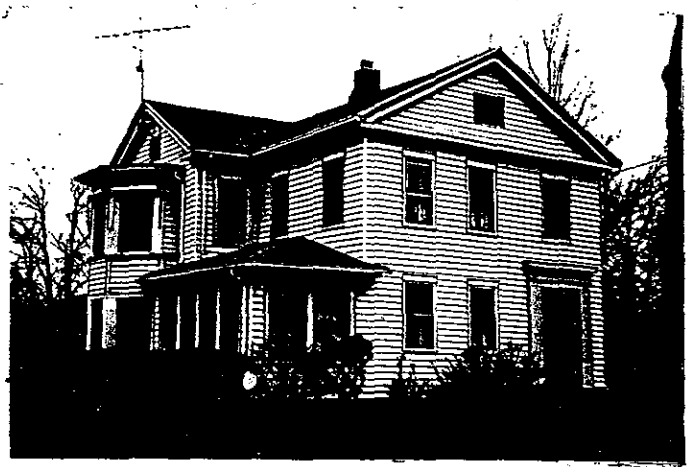
PHOTO	PHOTOGRAPHER	DATE
	Historic Resource Consultants	11/85
COMPILED BY	VIEW	NEGATIVE ON FILE
	W	A-0A
	NAME	DATE
	Bruce Clouette & Matthew Roth	3/86
20	ORGANIZATION	
	Historic Resource Consultants	
	ADDRESS	
55 Van Dyke Avenue, Hartford, CT		06106

13. INTEGRITY (Location): On original site Moved WHEN? _____ (Alterations): Yes No IF YES, EXPLAIN: Siding, sash

Three-bay facade, with entry on the right; simple pilaster-and-lintel surround. Victorian door with two round-arched panes. Full cornice return; rectangular attic-story window with alternating wide and narrow panes. Two-over-two sash. Enclosed porch on left side leads to full-height cross-gable wing. Two-story bay window on wing.

This house is a good example of Greek Revival architecture. Though updated with a bay window, porch, and new front door in the Victorian period and recently sided, the house embodies many of the distinguishing characteristics of the period. The orientation of the house, the doorway, and the cornice return create the Greek-temple appearance so popular in the period. The attic window, with its intricate glazing, is another typical feature found only in houses of this period.
